This wing-refinishing project is a continuation of my efforts to make my 1986 ASW-20B look and perform better than new. The project and this document are a work in progress and I will make periodic additions as the project moves down the road. So, If things sometime appear a bit untidy, please bear with me.

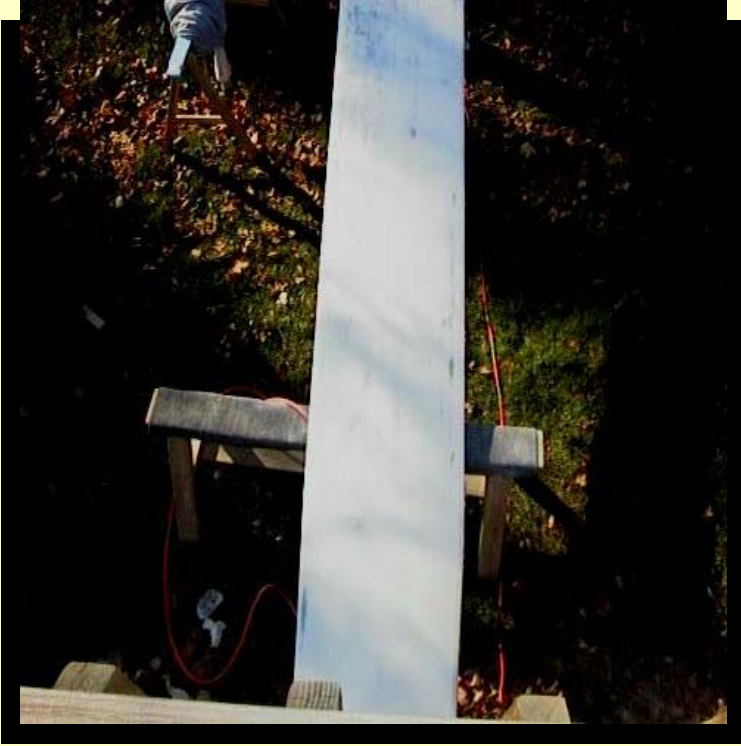
of the bottom of my sanded wing follows. The white areas are areas covered by thin gelcoat. All remaining gelcoat was examined with a 10-power scope to insure no crazing was evident.

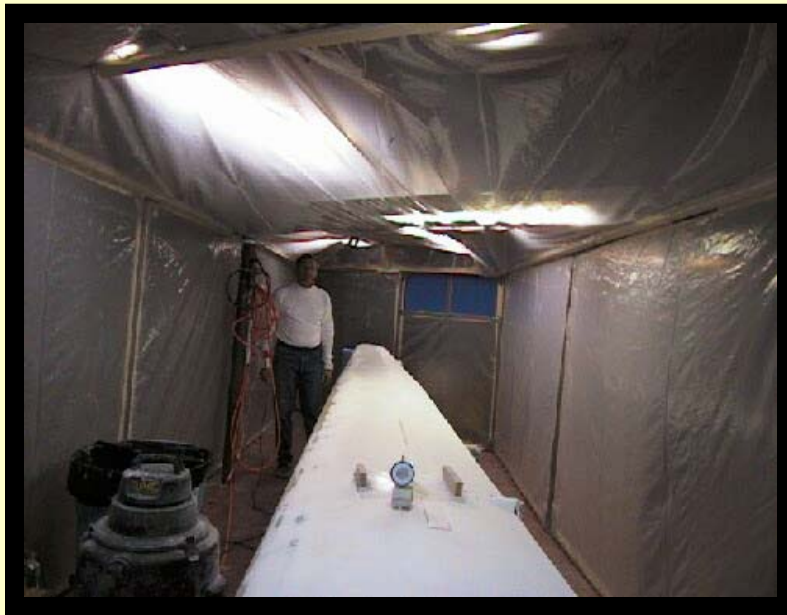
I sanded the next night using a contour sander made out of 1/8' Plexiglas. In 30 minutes, I had the spar section from root to spoiler sanded to a tolerance of 2 mills. The following picture shows the wing after the spar bumps were painted and sanded.

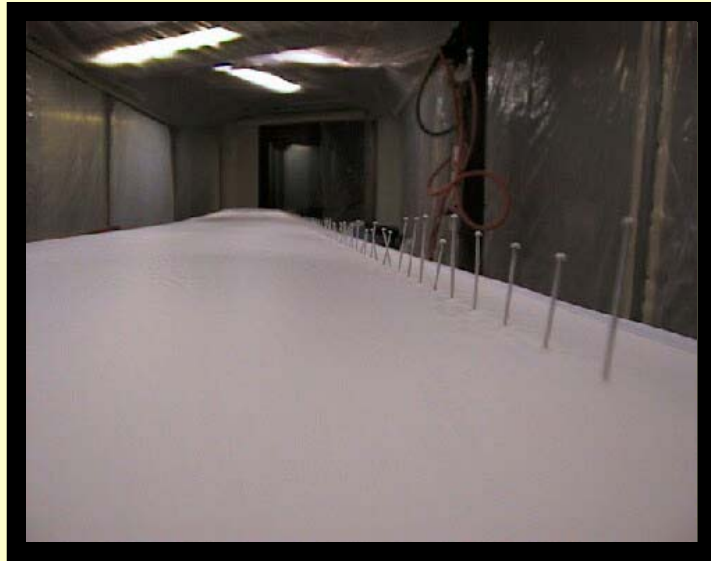
A line of straight pins extends to infinity. I actually have not counted, but remember seeing a note somewhere that each wing had 225 blowholes. Inserting a #17 silk pin into each hole takes approximately 30 minutes. I talked my wife into assisting on this run.
