This wing-refinishing project is a continuation of my efforts to make my 1986 ASW-20B look and perform better than new. The project and this document are a work in progress and I will make periodic additions as the project moves down the road. So, If things sometime appear a bit untidy, please bear with me.

Wing Gelcoat Removal

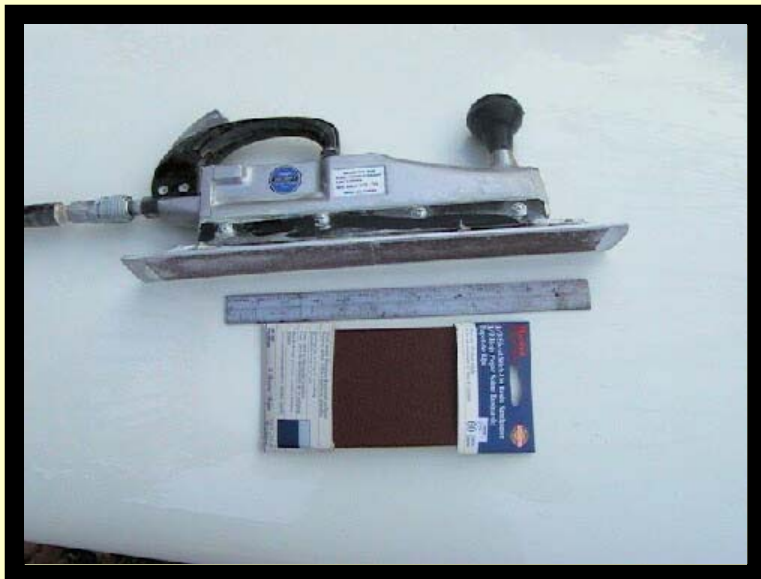
fiberglass surface, and you get a pattern of small holes appearing in the gelcoat. (See picture below) Change your pattern, until you run out of working room. Then start a new section and overlap the areas to get a continuous blotchy surface. To tell you the truth, sanding the gelcoat off is pretty boring; you just keep moving the air file and the glass surface slowly appears.

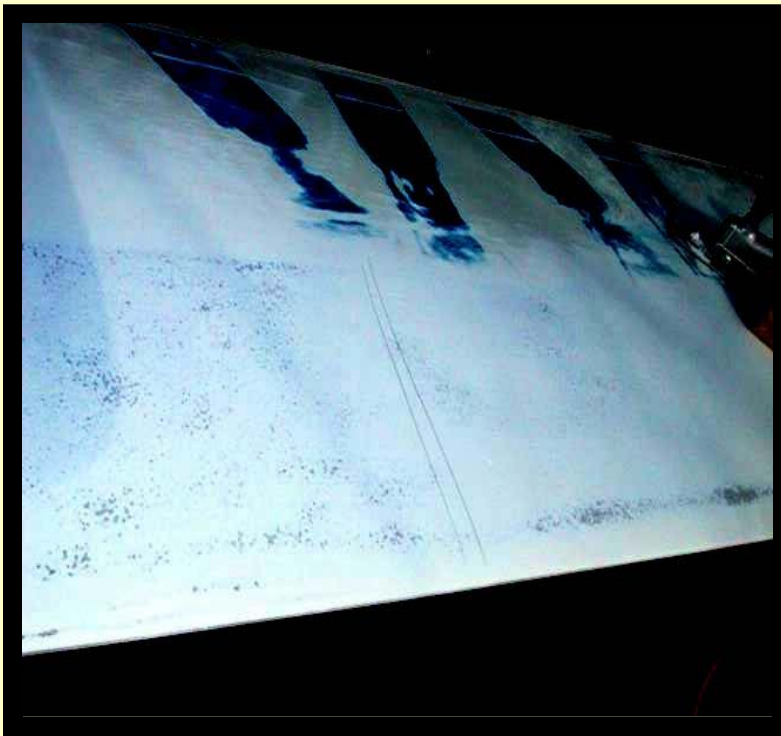
This picture shows some of my final surface, pending any decision to remove additional gelcoat. This is the bottom of my right wing; the root is on the left and the leading edge is at the lower end of the picture. The wing area on the left (of the two parallel pencil lines running from the LE to mid chord) was first sanded with the air file until the gelcoat was quite thin and the 'high' glass areas just started to break through. The glass is the gray splotches in the picture. I then used a palm-sized

random-orbital sander with 100 grit resin paper to sand those areas that were still completely covered by gelcoat. I am working left to right, so the area to the right of the parallel lines only shows the sanding pattern left by the air file; it clearly is less splotchy than the area on the left which was also sanded with the small orbital. While I think this level of sanding is fine for the shallow crazing on my glider, you may have to remove all the gelcoat to fix **your** crazing damage. This may be a good argument to refinish wings earlier rather than later.

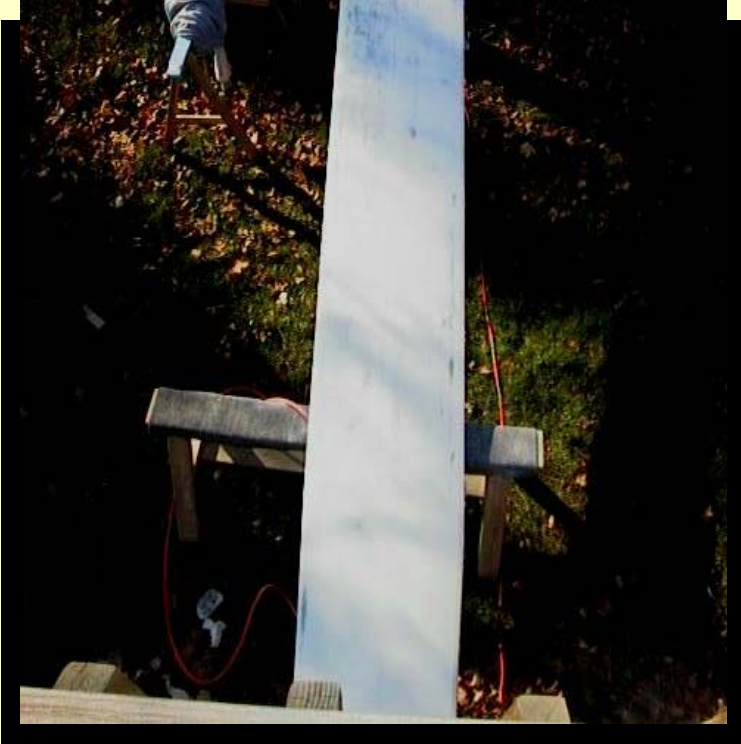
of the bottom of my sanded wing follows. The white areas are areas covered by thin gelcoat. All remaining gelcoat was examined with a 10-power scope to insure no crazing was evident.

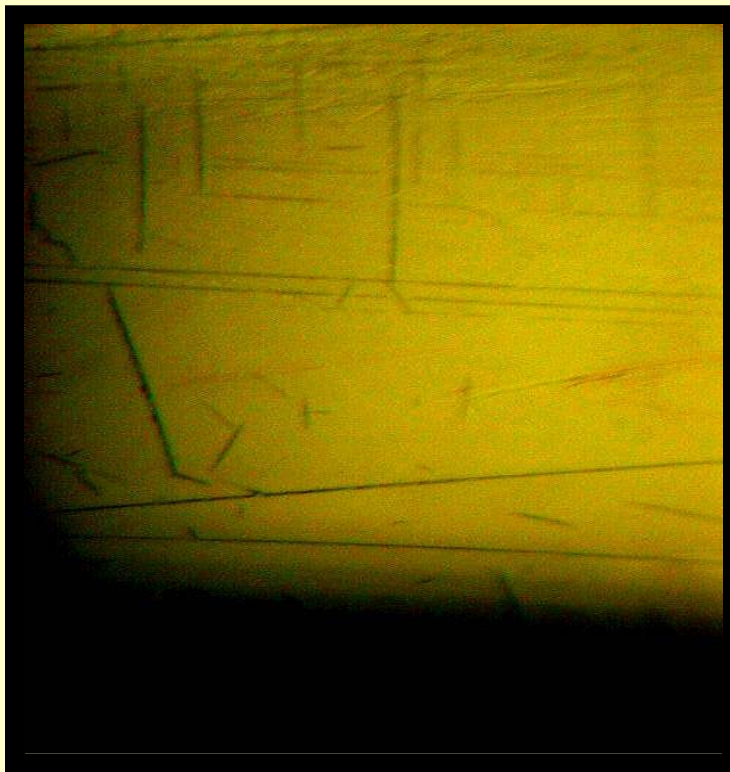
A magnified (10x) contrast enhanced picture of my leading edge crazing follows. This will be sanded down to the fiberglass surface. The airfile made the more lateral scratches in the upper area of the picture.

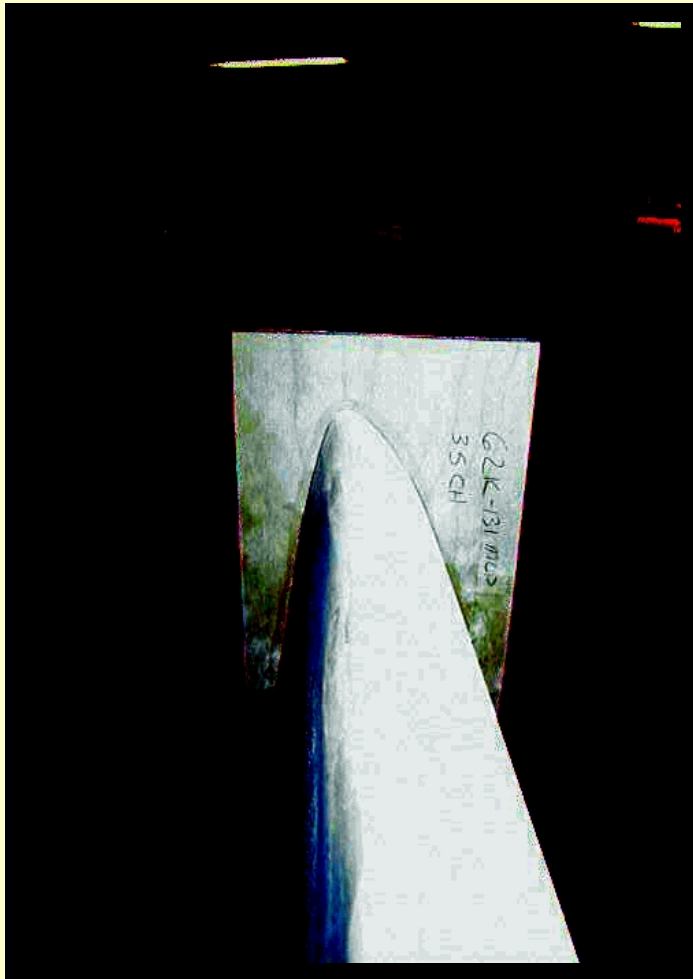
I have to finish sanding the leading edge so I stood the wing up on end to make the work easier. A quick check with the LE templates indicated that the leading edge was amazingly close to the design profile. The wing was most accurate from the root to the flap/aileron junction i.e. the planform break. The leading edge of the outer third of the wing deviated the most in that the nose (the 4 inches from LE) of the airfoil was too flat on top and bottom.

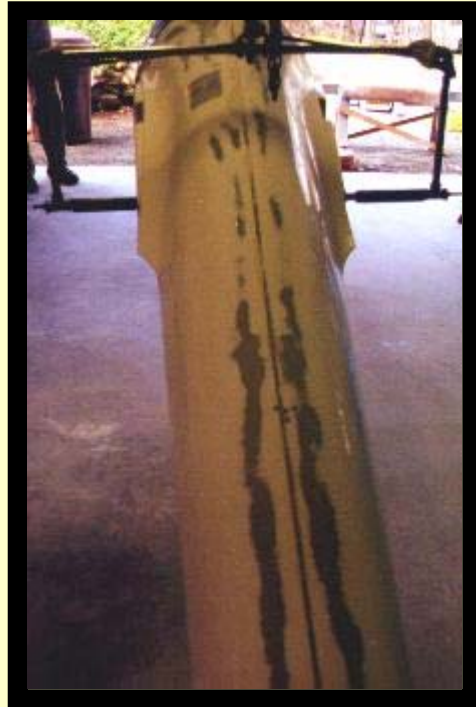
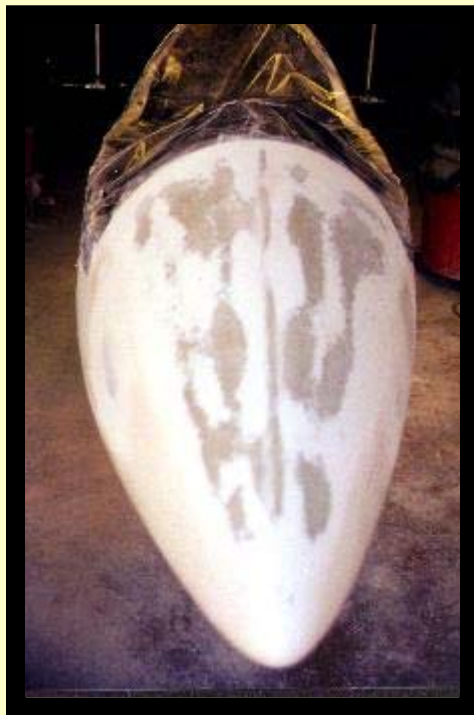
Photos 1 and 2 show the top of the tail boom and nose after the removal process. The filler that remained in the low areas was examined with a 10X scope and showed no cracking, so it was left on the glider.

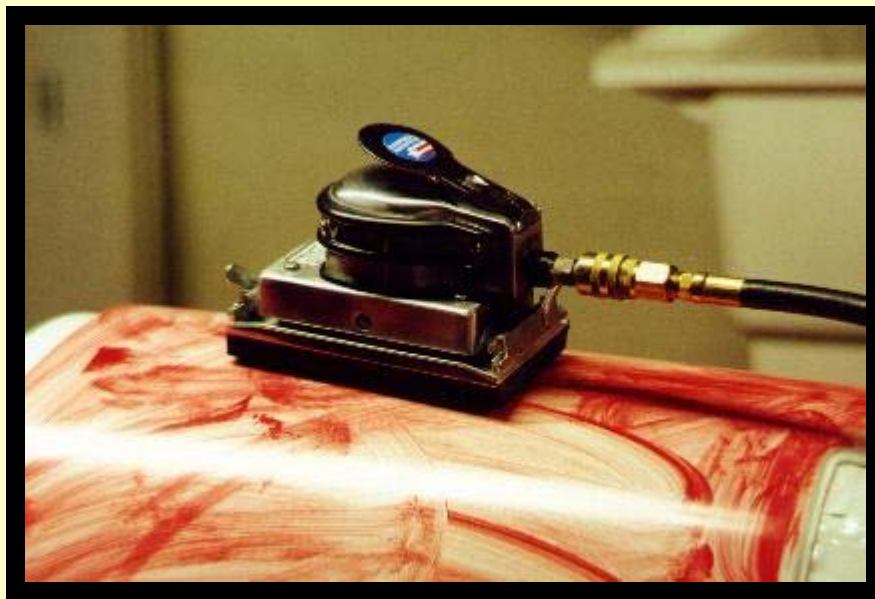
This photo shows the pattern that you first see as the top of the orange is sanded off.
