**Airworthiness Directive**  
**1993-001/3**

**L 'Hotellier ball and socket connectors**

**Subject:** L 'Hotellier ball and socket connectors with lock plates if installed in sailplanes, powered sailplanes and aeroplanes

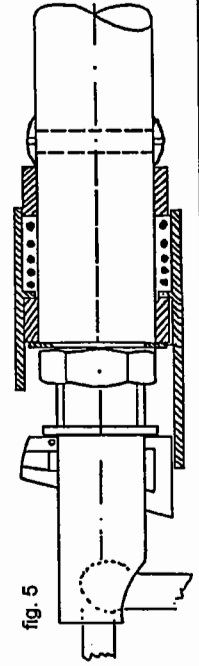
fig. 5

The following systems to secure l'Hotellier ball and socket connectors are LBA-approved: Uerlings sleeves or Uerlings type sleeves (see section III), safety pin (figures 2 and 2a), LS-safety sleeve (figure 3), Schempp-Hirth spring (figure 4) und Wedekind locking system (figure 5).

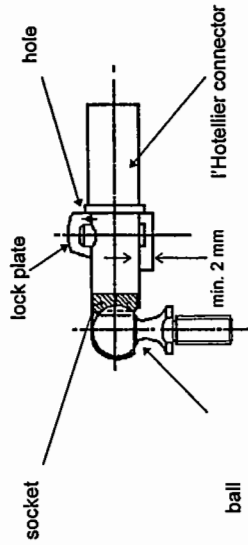
**Section IV**

The socket is to be slid completely over the ball with the lock plate pressed down. During locking the lock plate moves back slightly so that in a correct connection the hole on the narrow edge of the lock plate becomes visible.

The safety pin is to be inserted in this hole thus securing the ball and socket connector.

By loading the connection full engagement of the ball is to be verified!

Warning!  
 Unsecured ball and socket connectors may open automatically in flight.

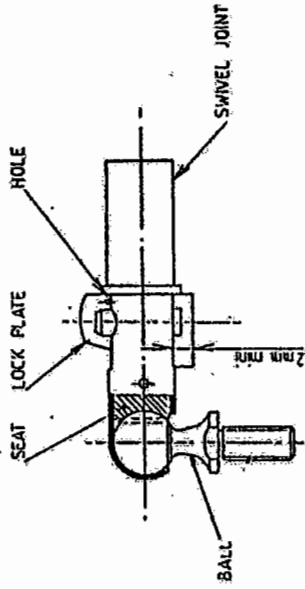
FIG. 1

2.5. MEASUREMENT OF THE LOCKER LOWER PART PROJECTION AFTER ASSEMBLY OF THE SWIVEL ON THE BALL (see fig. 1)

This projection must be higher than 2 mm.  
The aim of this requirement is to verify the efficiency of the automatic take up clearance

If after these verifications, one of the above check is out of tolerance, it is mandatory to replace both ball and swivel. nevertheless it is recommended to replace this assembly every 10 years or every 3000 flight hours.
