**Airworthiness Directive**  
**1993-001/3**

**L 'Hotellier ball and socket connectors**

**Subject:**  
L 'Hotellier ball and socket connectors with lock plates if installed in sailplanes, powered sailplanes and aeroplanes

**Attachment to Airworthiness Directive No. 1993-001/3  
L'Hotellier ball and socket connector, lock plate**

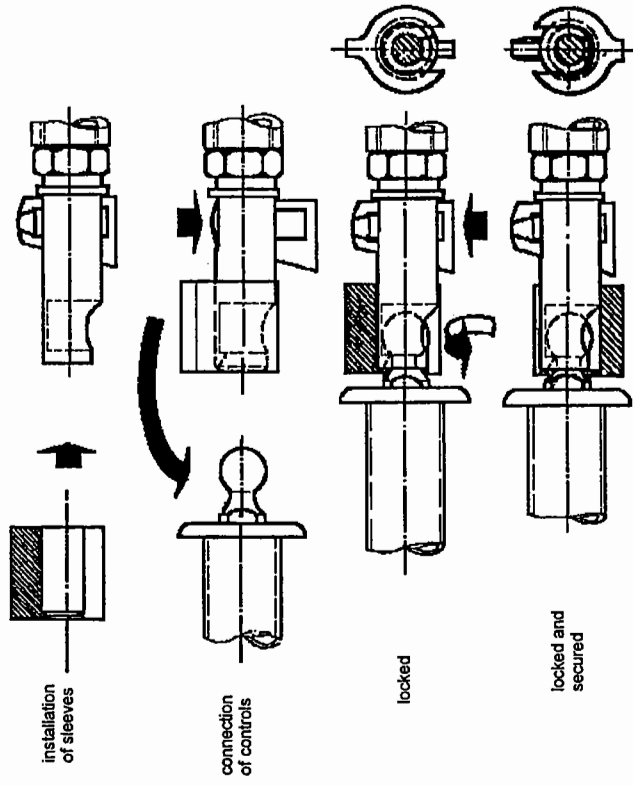
**Section III**

For installation, the sleeves have to be slid axially onto the l'Hotellier ball and socket connectors. They may by no means be clipped radially onto the l'Hotellier ball and socket connector. Radial clipping (excessive opening of the sleeve) may lead to cracks or ruptures due to overstressing so that the sleeve cannot function properly any more.

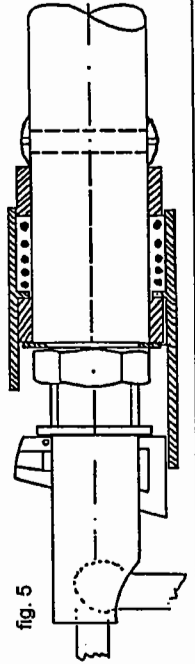
**Section II**

The following systems to secure l'Hotellier ball and socket connectors are LBA-approved: Uerlings sleeves or Uerlings type sleeves (see section III), safety pin (figures 2 and 2a), LS-safety sleeve (figure 3), Schempp-Hirth spring (figure 4) und Wedekind locking system (figure 5).

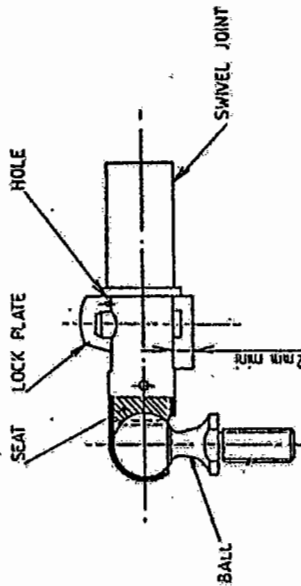
FIG. 1

2.5. MEASUREMENT OF THE LOCKER LOWER PART PROJECTION AFTER ASSEMBLY OF THE SWIVEL ON THE BALL (see fig. 1)

This projection must be higher than 2 mm.  
The aim of this requirement is to verify the efficiency of the automatic take up clearance

If after these verifications, one of the above check is out of tolerance, it is mandatory to replace both ball and swivel.  
nevertheless it is recommended to replace this assembly every 10 years or every 3000 flight hours.
