Kind : Maintenance instruction.

Effectivity : All ASW 20s and ASW 20 Ls.

ASW 20  
Maintenance Instruction  
D

*Alexander Schleicher*  
Segelflugzeugbau  
6416 Poppenhausen

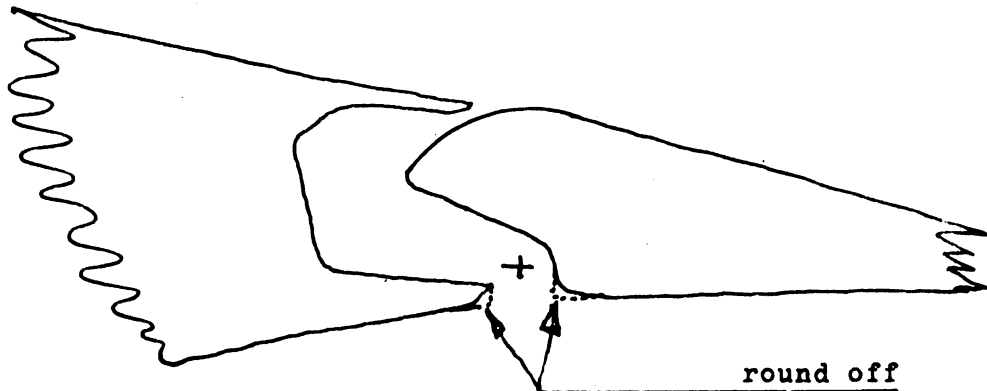
- A) High frequency turbulence in wind shear layers.
- B) Strong turbulence.
- C) Shaking of the control stick by the pilot or blows with the hand to the side of the stick.
- D) Airbrake cover plates being not completely closed.
- E) Fluttering tape (lower wing surface). Apparently this may happen if the tape - over a greater part of the wingspan - is no longer folding inwards into the control gap but if it is folding to the outside; then it has the same effect as an airbrake which is a little extended. The folding of the tape to the outside also causes considerable losses in performance, especially in flap position 1 (-11°).

1. The airbrake over center lock is tightened according to Maintenance Instruction C for ASW 19 and ASW 20. The notes given in the ASW 20 Operations Manual on page 39 (ASW 20 L; page 43) must be observed.
2. Fluttering tape as well as any tape folding to the outside between the control hinges is replaced by new tape. For serial production 38mm tape is now used. It has been found that it pays if the edges of the wing and the controls are carefully rounded off so that the tape folds more easily to the inside of the gap.

When applying the tape, you must take care that the tape is not tightened too much when the flap is full up (see ASW 20 Flight Manual page 42, for ASW 20 L see page 46), i.e. a deflection of 49mm measured at the trailing edge of the flap root rib, or when the aileron is full up, i.e. a deflection of 32mm measured on the outboard end of the trailing edge. As the tape may shrink a bit with moisture (it is made of cotton), it must not be too tight in these configurations otherwise full aileron deflections in flap position 1 are no longer possible.
