Subject :

Inspection of aileron weight and aileron c.g. and inspection of play (backlash) in aileron and flap control circuits to avoid flutter risk.

Glider model ASW 20, s/n 20 001 thru 20077 and 20 086.

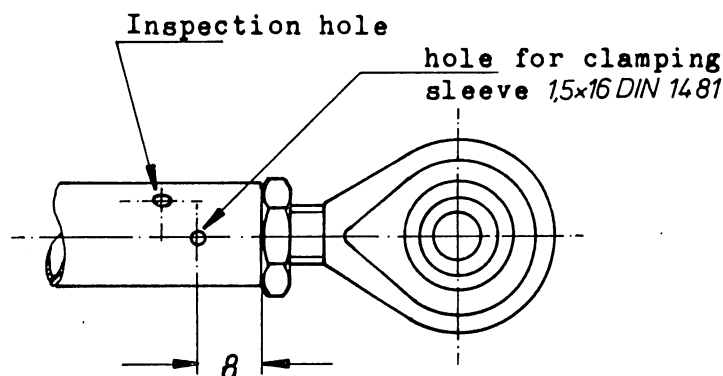
4. Please check if the lever at the mixer is at the end of the track when the flap handle is locked in position 1 (-11°).
If the handle can be pushed past the hole of position 1, one of the spheric ball joints of the flap pushrod, which is found on the left cockpit wall, must be turned in to shorten the pushrod. This must be done until the flap handle can just be locked in position 1 as the end of the track in the mixer is now touched.
After adjustment both spheric ball joints must be safetied by 1,5mm clamping sleeves against being turned out (in addition to the nuts).
