This wing-refinishing project is a continuation of my efforts to make my 1986 ASW-20B look and perform better than new. The project and this document are a work in progress and I will make periodic additions as the project moves down the road. So, If things sometime appear a bit untidy, please bear with me.

Wing Gelcoat Removal

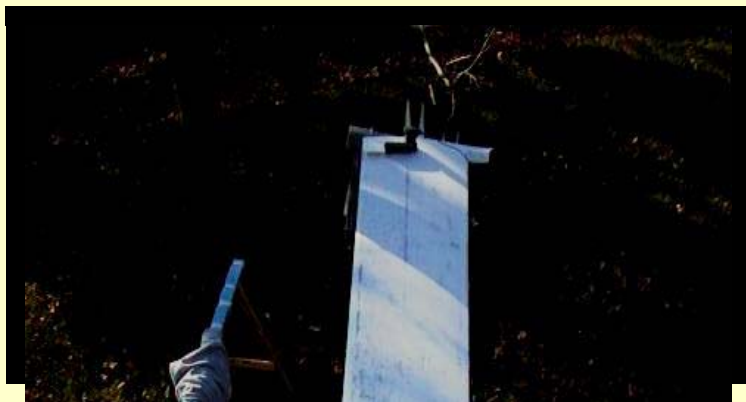
I have expended about 10 hours on each wing side to remove gelcoat to this level. In addition, I will have to spend some additional time removing all the gelcoat from my leading edge, which is crazed all the way to the glass surface. I will use a small sanding block and 100 grit

resin paper to finish the job on the leading edge started by the air file and orbital sander; although I may give the air file another try with less coarse paper. The air file was extremely easy to control and I was able to bring it a good distance around the leading edge as I sanded wing surfaces. I also used the orbital to again assist in the low areas. Since we have had a very mild November (1999), I was also able to work outside for two consecutive weekends. I don't know how I would have managed the dust working in my basement as originally planned. A picture

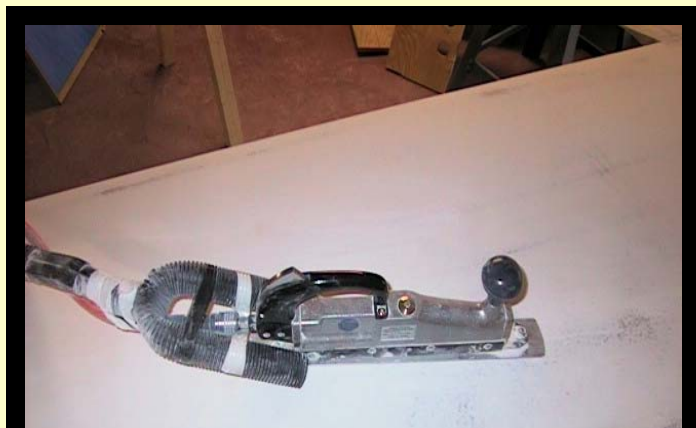
As the weather returned to normal November temperatures, I moved indoors to continue working. I fabricated the following collector for my air file. Sump pump hose was used to fabricate a Y-shaped pickup nozzle, which straddles the air file. The air file does not throw much gelcoat; material tends to gather on each side of the

blade. The nozzle sucks the loose material off the surface and also does a good job pulling dust out of the air around the tool. Suction is supplied by large (low noise) shop vac; the shop vac hose runs up the high-pressure airline to the air file. This mod and the shop vent fan keep the air virtually dust free.

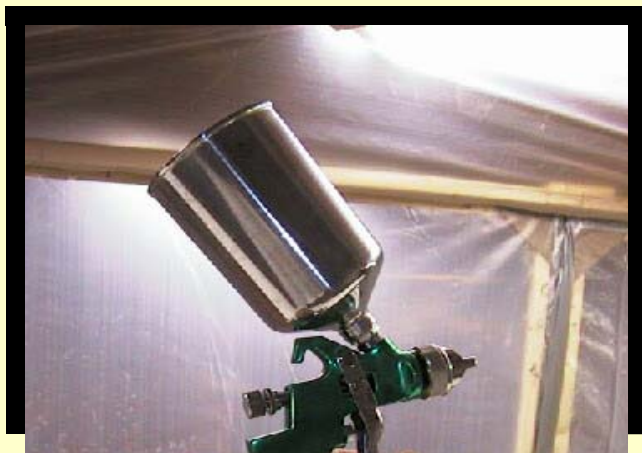
The next step involved spraying the top of the wing with Simtek Sanding Surfacer to smooth out the spar bumps. I applied one quart of material to the upper wing surface, extending the pattern 4 - 6 inches on each side of the spar. I applied three coats of material, at 30-minute intervals, using a quart of Surfacer total. By the way, I used a new gravity feed spray gun, which allowed spraying thick fillers

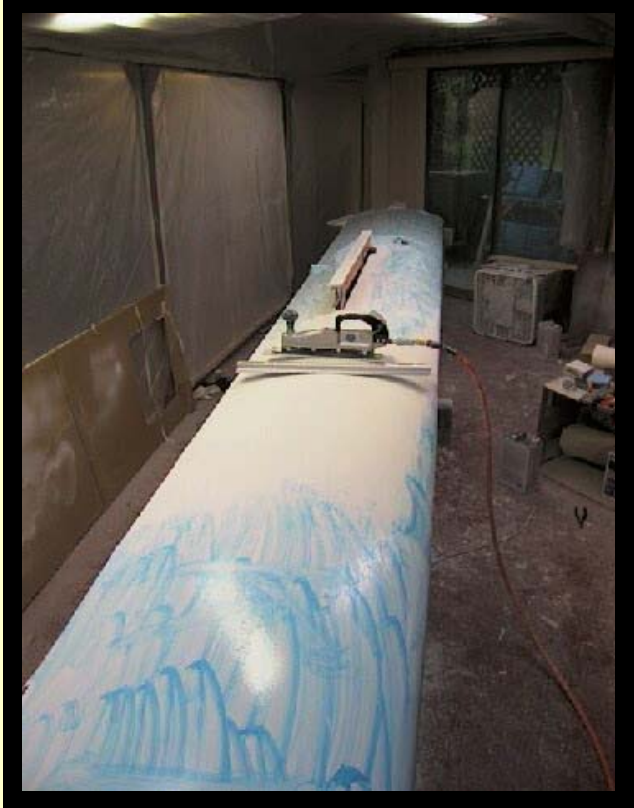
The paint dried with the typical orange peel. I then applied a mixture of thinned dope over both wing surfaces to disclose sanding progress. You simply have to sand until the blue is gone.

I use the air file to knock the high points off the paint (just about to the bottom of the orange peel) and then hand sand with a two-foot bar sander to remove the remaining blue. I also immediately sanded the spoiler area to see if I had any coverage or fit problems.

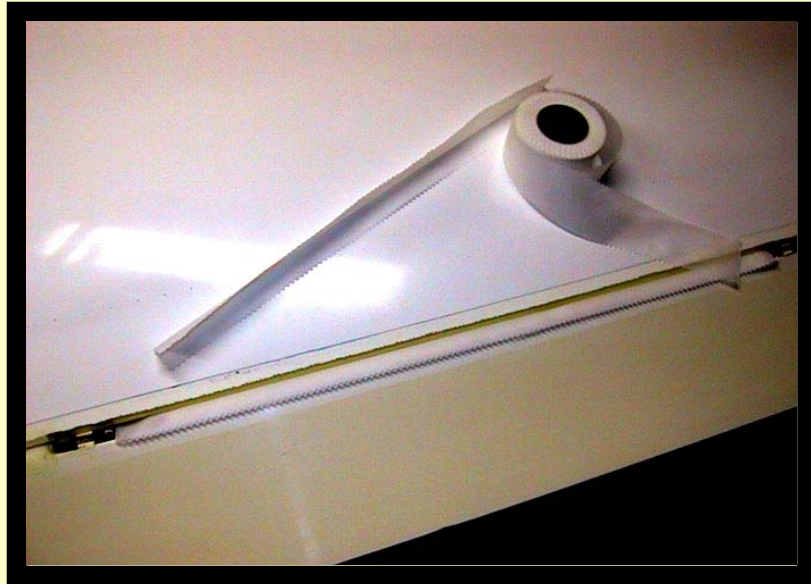
I made my seals out of a 2" roll of lightweight aircraft dacron purchased from Aircraft Spruce. First, rough-cut the length to fit in between the hinges and then precise cut just before application. Once the length is correct, hold the strip at the ends and fold it over between your fingers, holding tension and rubbing the strip against the trailing edge of the wing to set the crease. This "V"-shaped piece of dacron is then inserted into the gap. I then

used a small stiff solder flux brush to apply thinned contact cement to the wing and the top layer of dacron. The top layer of dacron is then folded onto the wing edge and additional thinned cement is brushed on to insure good adhesion. The other side of the seal is attached to the control surface by folding the dacron back to apply cement to the dacron and control surface. Once I was rolling, each section took about 10 minutes . the entire wing was sealed in about two hours. I let the dacron seals sit overnight and applied the mylar at the next session. The curved mylar seal was applied using transfer tape per the standard procedure. Since the mylar was being attached to a contact cement impregnated dacron surface (not on top of Teflon tape) the work went quickly and the bond was excellent.

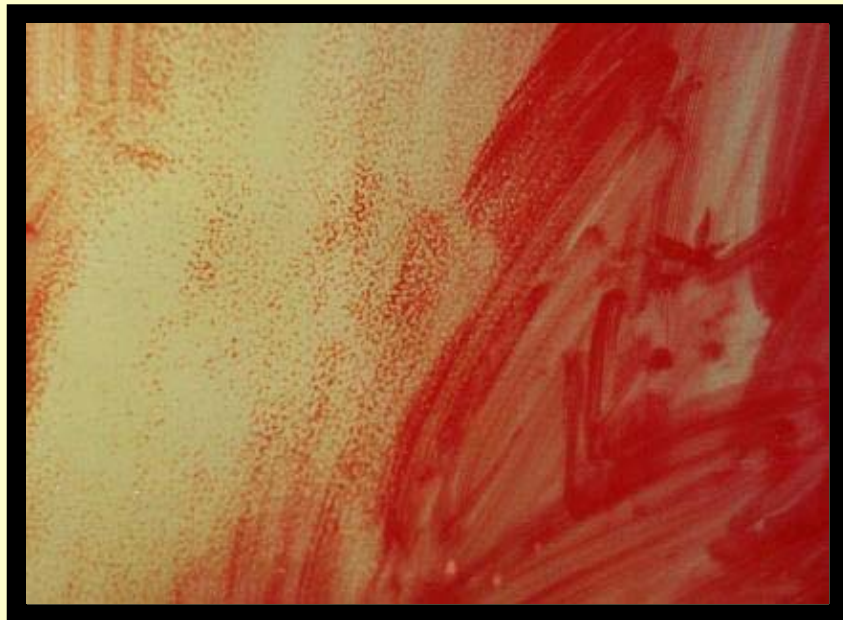
The disclosure agent will also identify pinholes and areas that need some touch up spraying. Pinholes can be fixed with a dab of gelcoat on a fine brush. Clean the disclosure agent with dope thinner first ... and rough up the hole so the micro patch gets a good bite. If you hit a larger defect, you can build up the area using an airbrush with the 'big' nozzle. So, as you're sanding, be prepared to stop if 90% of the surface looks fine. You could wind up sanding all the good stuff off, which simply means you will have a bigger area to repair.
